CRANFIELD INSTITUTE OF TECHNOLOGY

RADIAL INFLOW TURBINE STUDY

SEVENTH INTERIM REPORT

Dr S Hamid
Prof R L Elder

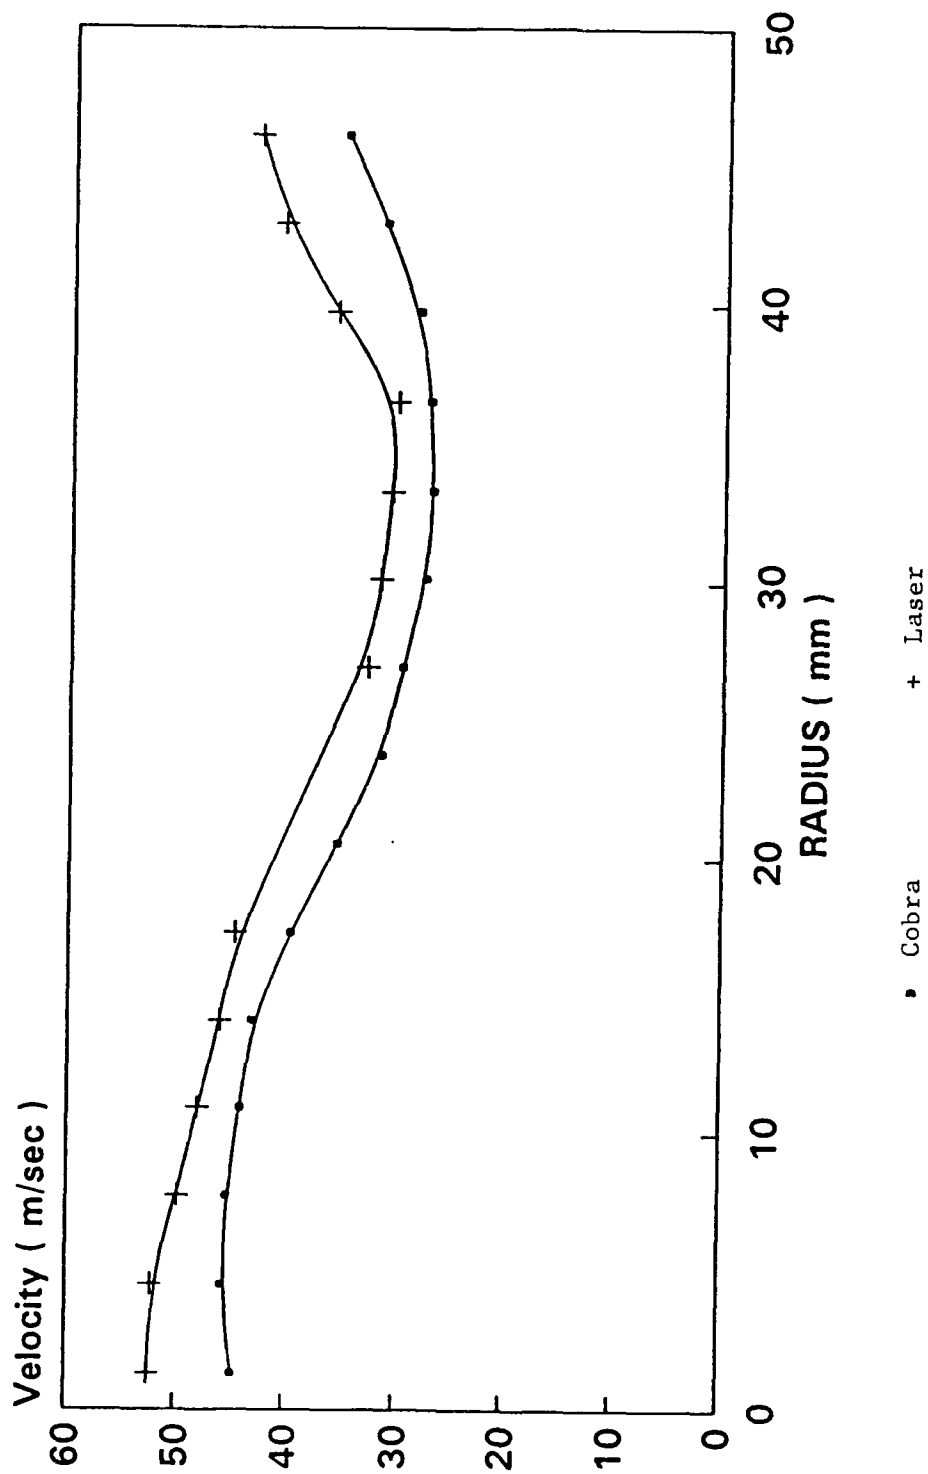
Figure 2

CRANFIELD LA MEASUREMENTS

Window A : PR = 3.0 : $U/V = .64$

Figs 2 and 3 give the laser anemometry and pressure probe results for pressure ratios of 3.0 at $U/V = .64$. Fig 2 gives the velocity variation along the radius of the duct at window A whereas fig 3 shows the swirl angle variation for different radial positions. Figs 4 and 5 show the results for the same window but at a different running condition ($U/V = .64$, $PR = 3.5$). Results for all the other running conditions have now been completed which will be presented in the final report.

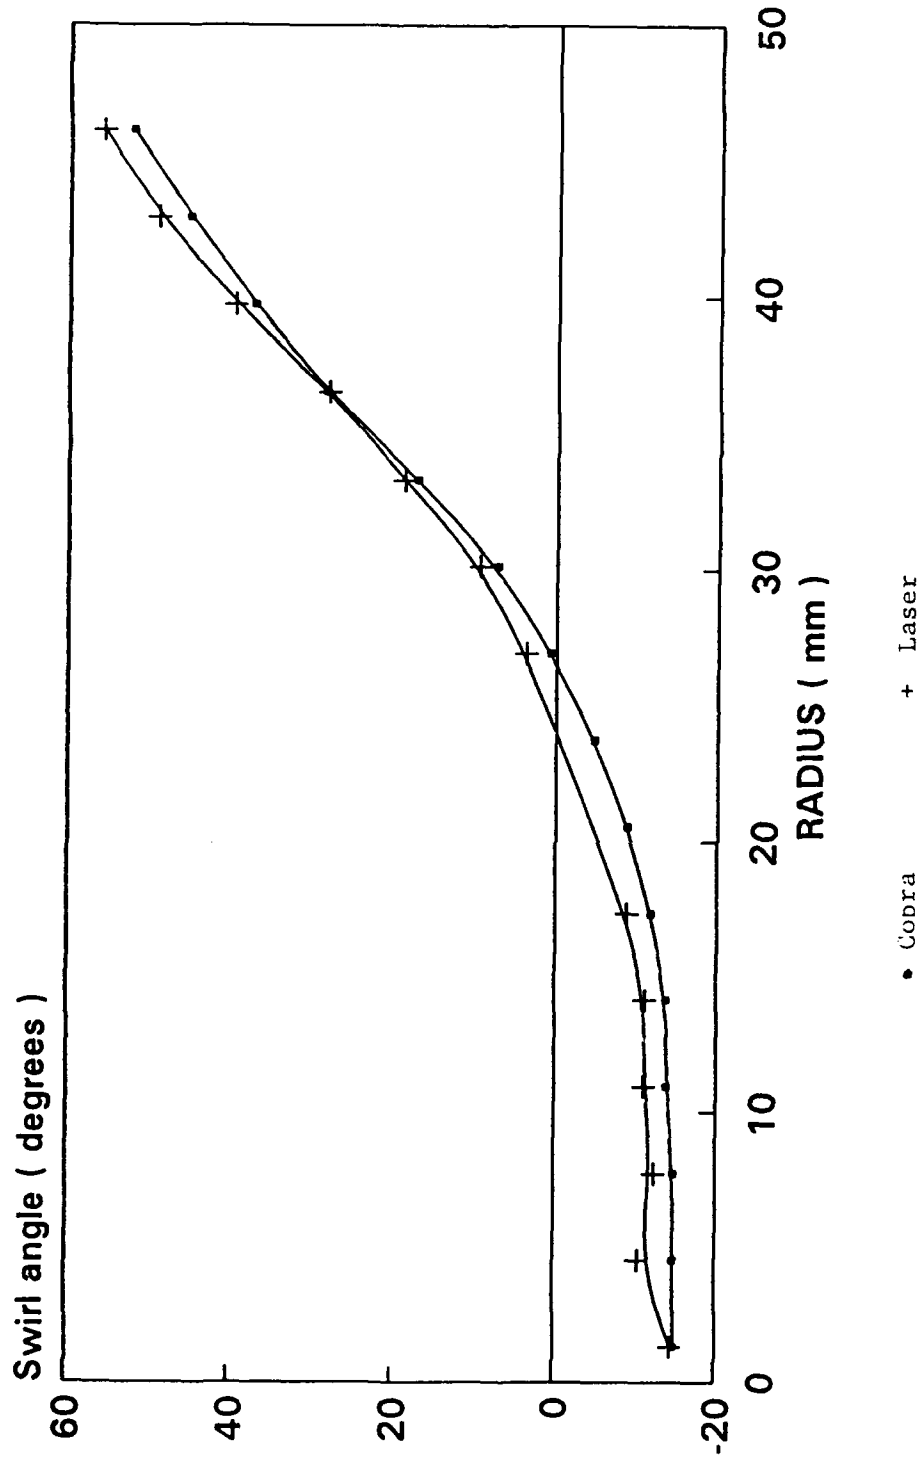
Figure 3

CRANFIELD LA MEASUREMENTS

Window A : $PR = 3.0$: $U/V = .64$

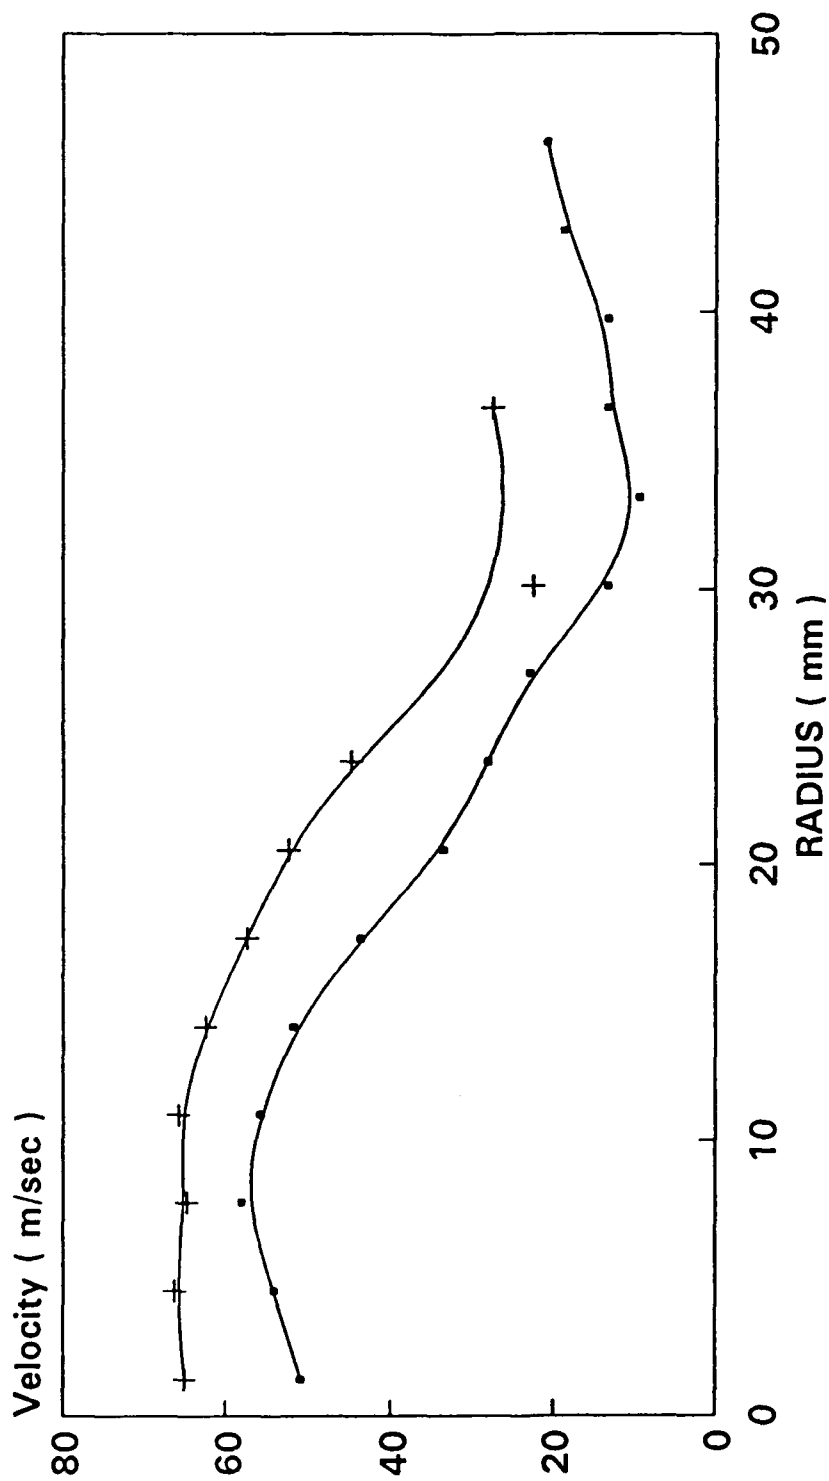
Figure 4

CRANFIELD LA MEASUREMENTS

Window A : PR = 3.5 : U/V = .64

• Cobra + Laser

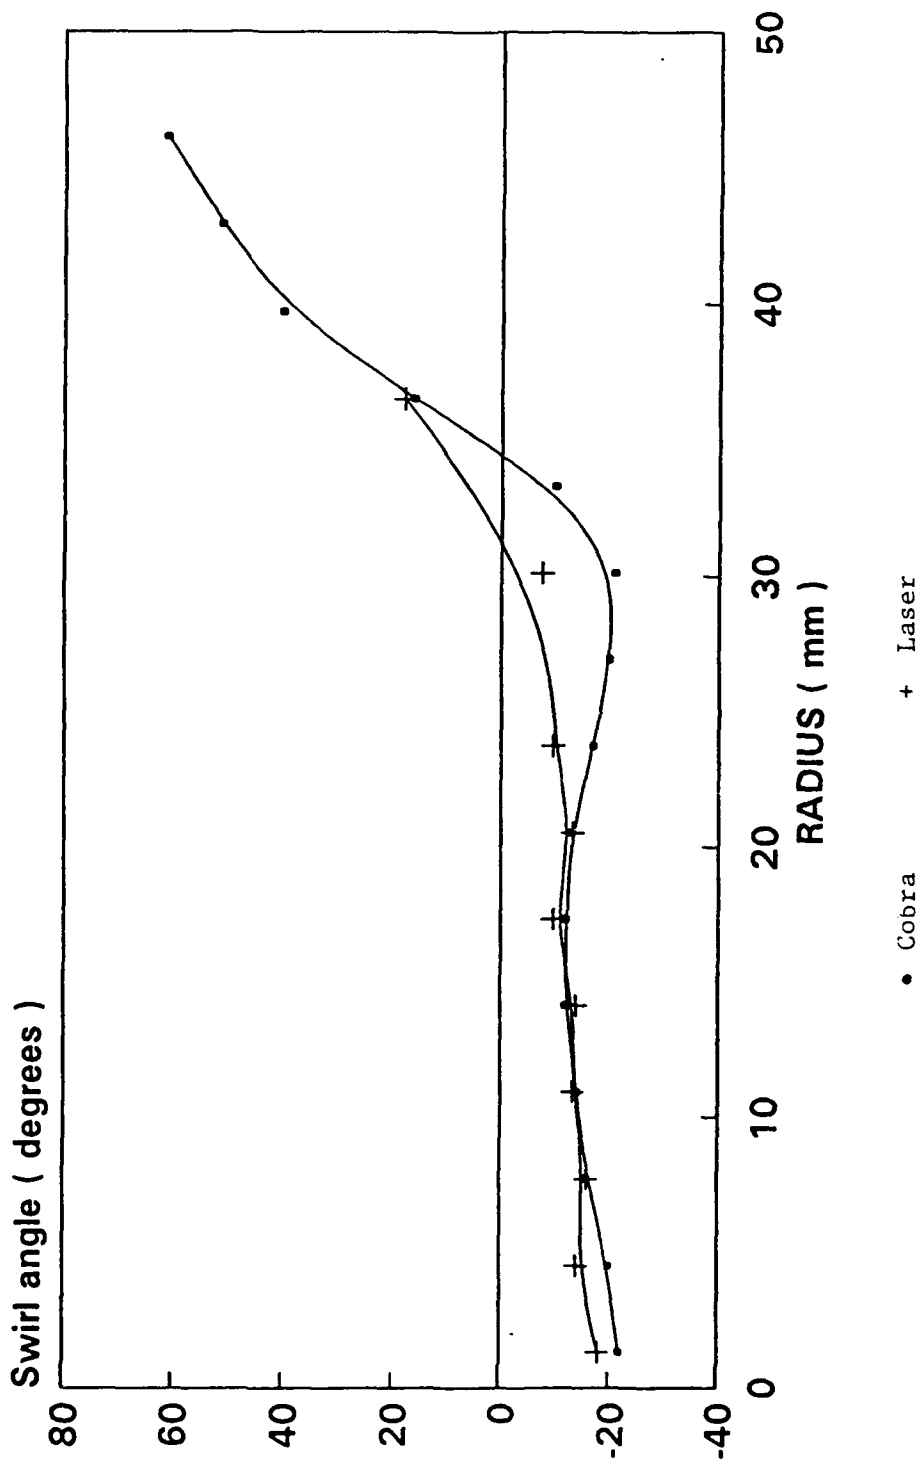
Figure 5

CRANFIELD LA MEASUREMENTS

Window A : $PR = 3.5$: $U/V = .64$

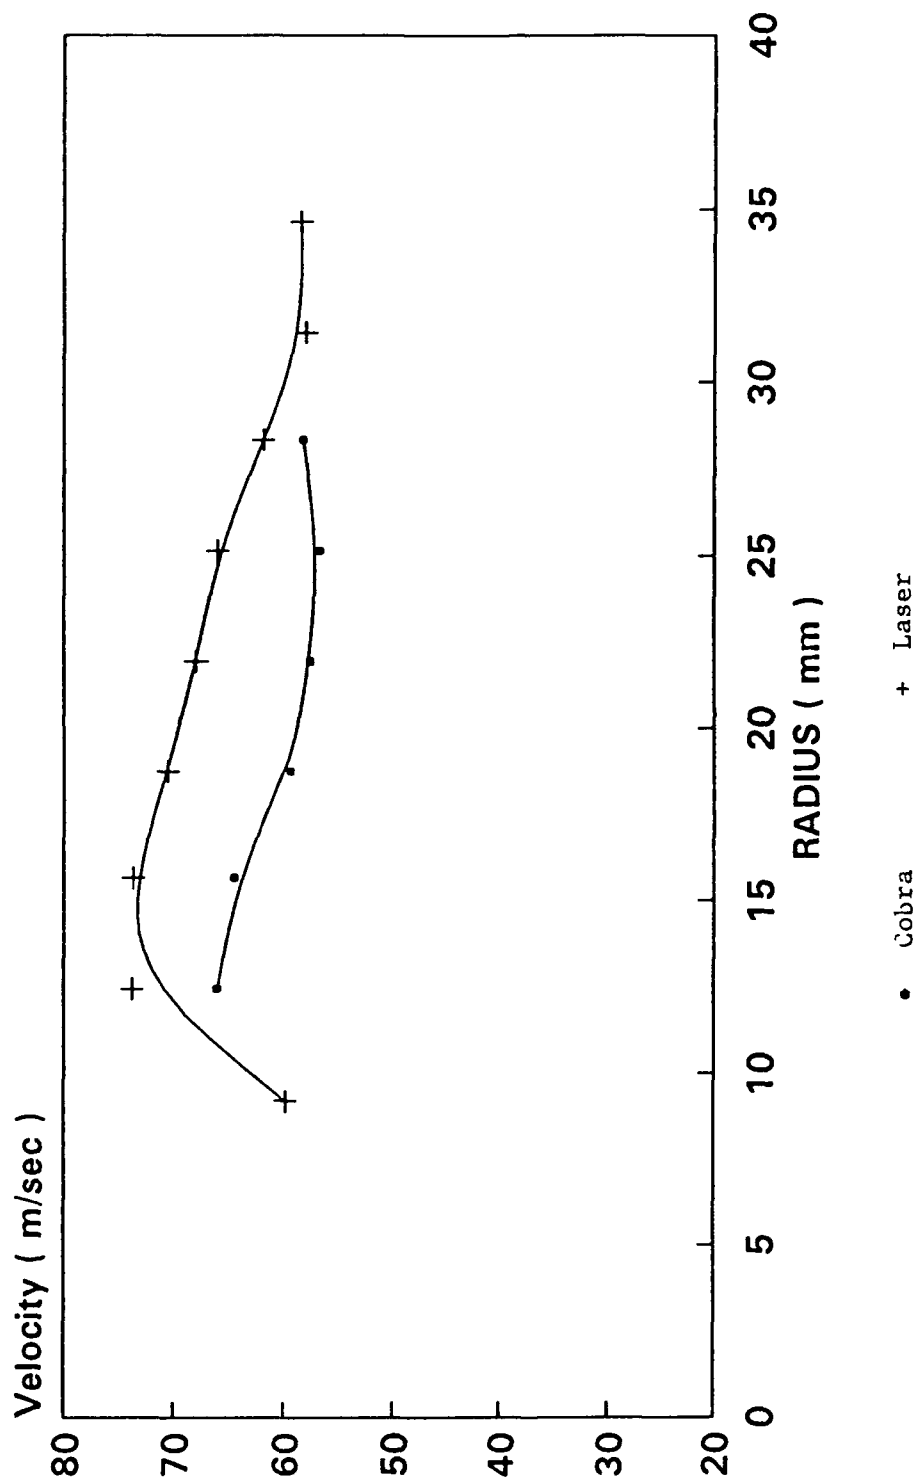
Figure 6

CRANFIELD LA MEASUREMENTS

Window B : $PR \approx 3.0$: $U/V = .64$

Figs 6 and 7 give a comparison of laser anemometry measurements with those obtained by the Cobra probe for the same running conditions ($U/V = .64$, $PR = 3.0$) and approximately at the same radial positions. Results for the other running conditions have also been completed. Discussions on these results will be included in the final report.

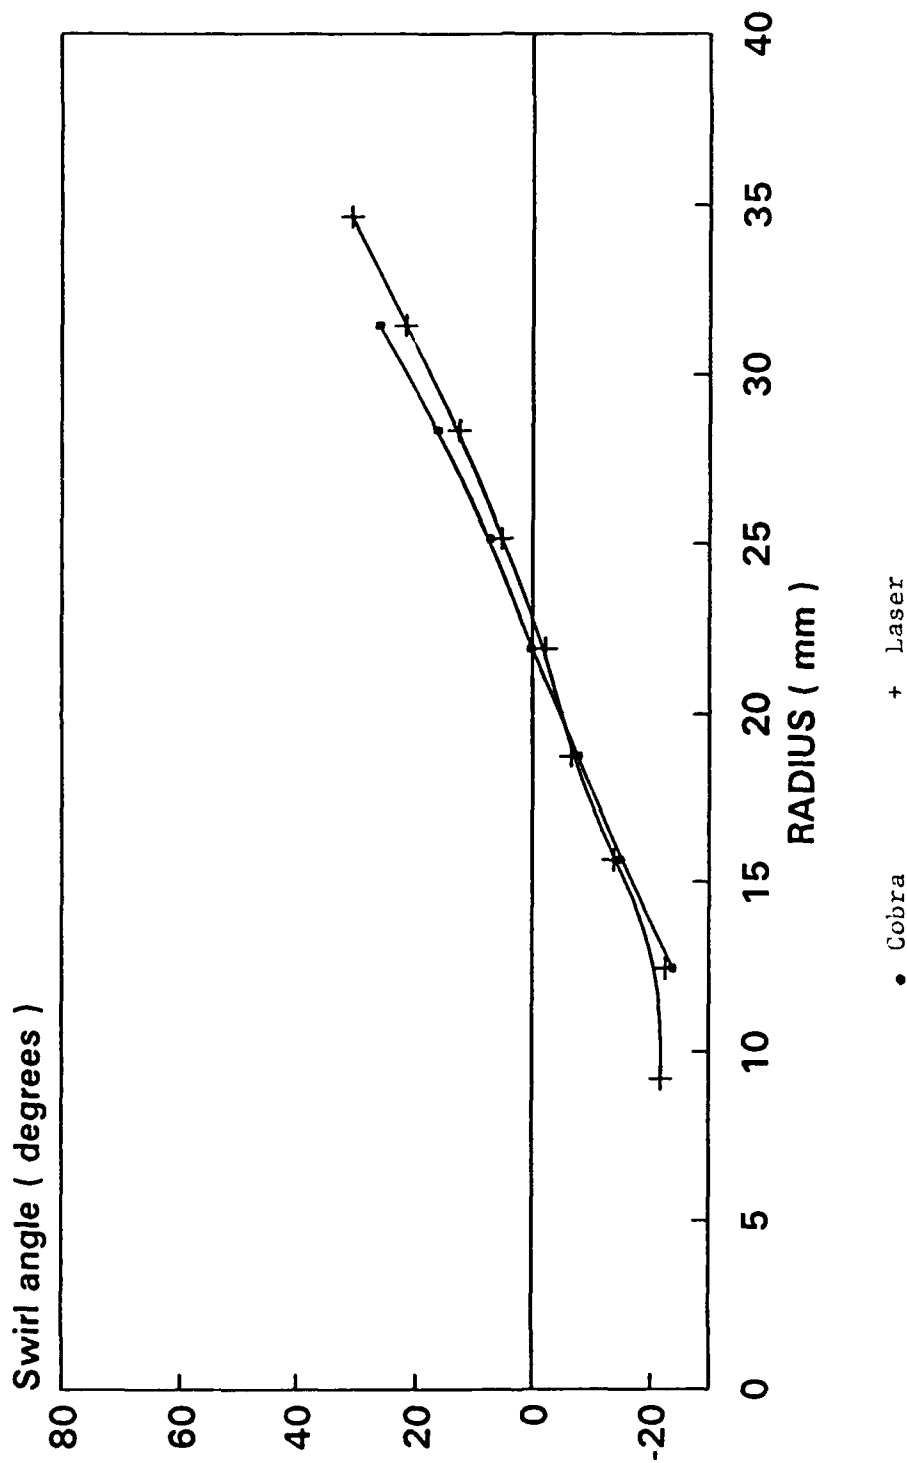
Figure 7

CRANFIELD LA MEASUREMENTS

Window B : $PR = 3.0$: $U/V = .64$
